SSEN Cambushinnie 400kV Substation Upgrade
Additional Peat Probe Survey

Technical Note: Additional Peat Probe Survey

Client name		Project name	Project number
Scottish & Southern Electricity Networks (SSEN)		Cambushinnie 400kV Substation	60721943
Prepared by	Checked by	Verified by	Approved by
Daniel Whitley	Sean Taylor	David Raeside	Oli Nofal
Date: 15.03.2024	Date: 26.03.2024	Date: 26.03.2024	Date: 26.03.2024
Document No.	Revision	Date	
-	0	26 th March 2024

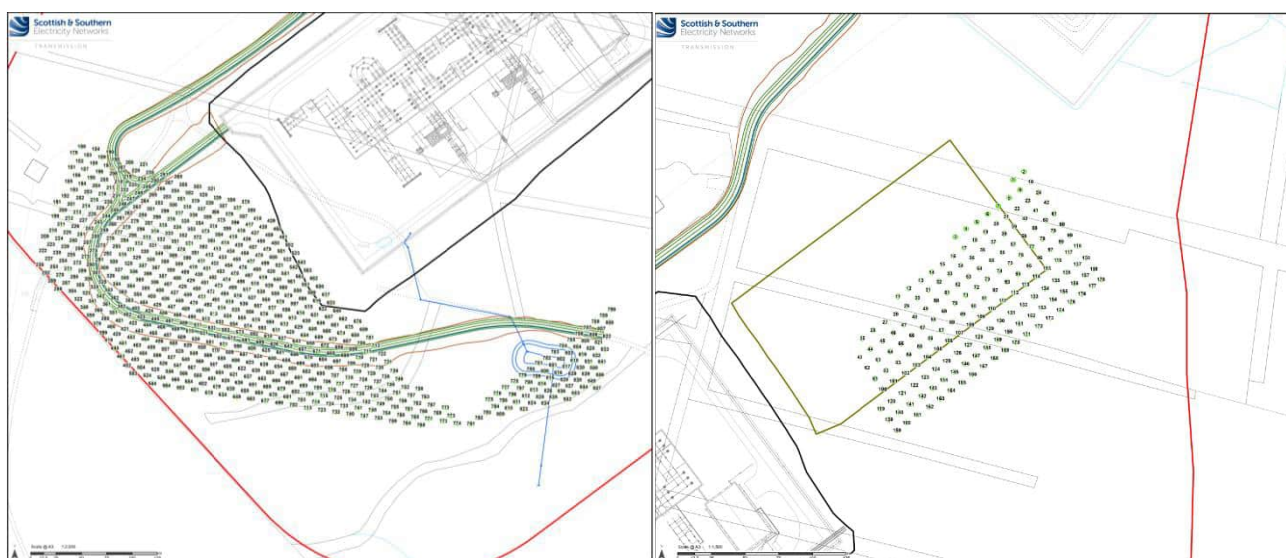
Insert 1: Peat Probe Locations

The additional peat probing was carried out by AECOM during March 2024 and was proposed to comprise of 847 probes on a 10m x 10m grid covering areas of the proposed works site which were not investigated as part of the initial peat probing by Igne in late 2023. The peat investigation can be split into two key areas: a small area northeast of the proposed substation and southwest of the existing substation covering areas of the proposed Contractors compound and a large area south and southwest of the proposed substation largely covering the proposed new access track and SuDs network. The smaller compound area comprised 178 probe locations whereas the larger area comprised 669 probe locations. See Insert 1 which shows these two areas.

During the site works, two areas were identified where trees were still present within the site. Within these areas it was not possible to safely undertake all of the probe hole locations. The two areas in question both relate to the larger probing area of the site. Figure 1 within Appendix A shows the areas where probes were cancelled and provides photographs of the condition. The first area indicatively shown by the red block in Figure 1, comprised mature trees which were severely windblown and had either collapsed or partially collapsed. This made the area inaccessible to the peat probing team. The second area indicatively shown by the purple block in Figure 1, comprised dense semi-mature trees where access could not be made easily and safely. Probing in these areas was undertaken where access could be made safely, however, 390 probes were cancelled due to the access and safety concerns. A further 15 probe locations were also cancelled due to the presence of overlying rock fill or gravel track. The peat probe result table in Appendix B provides the results of the probing exercise and where not undertaken, provides reasoning for this.

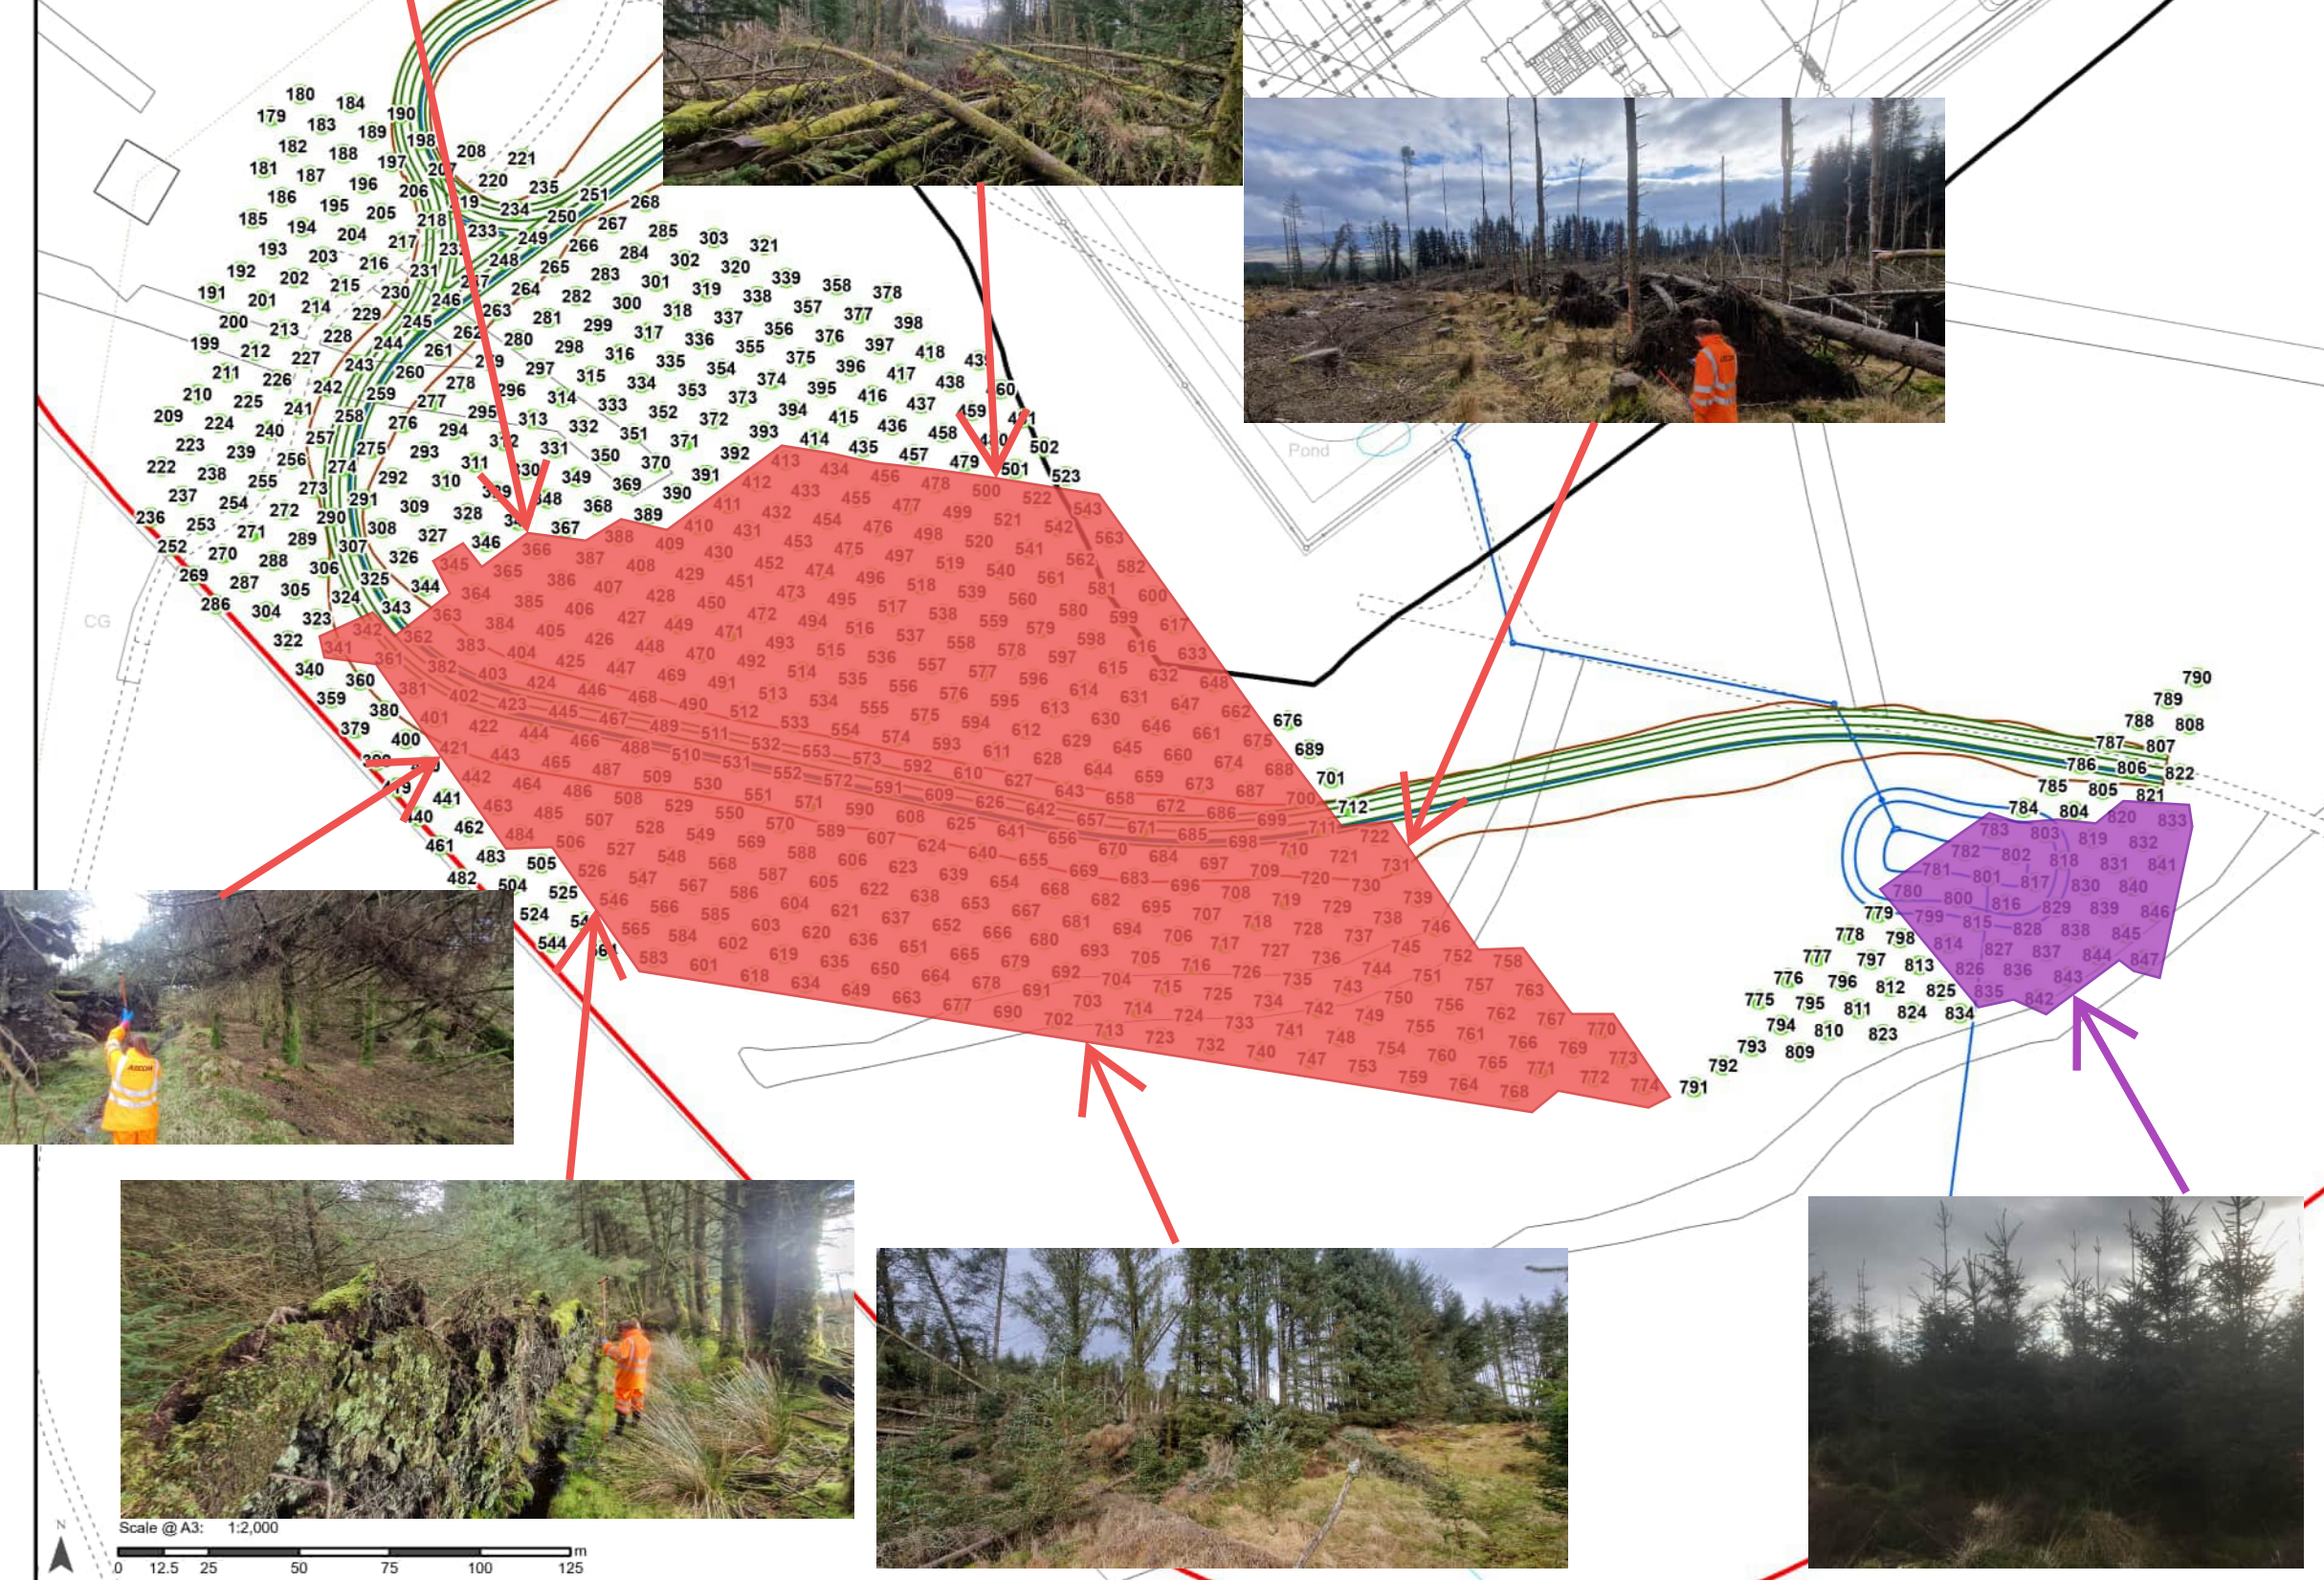
Drawing: Figure 1

Title:
Peat Probe Locations

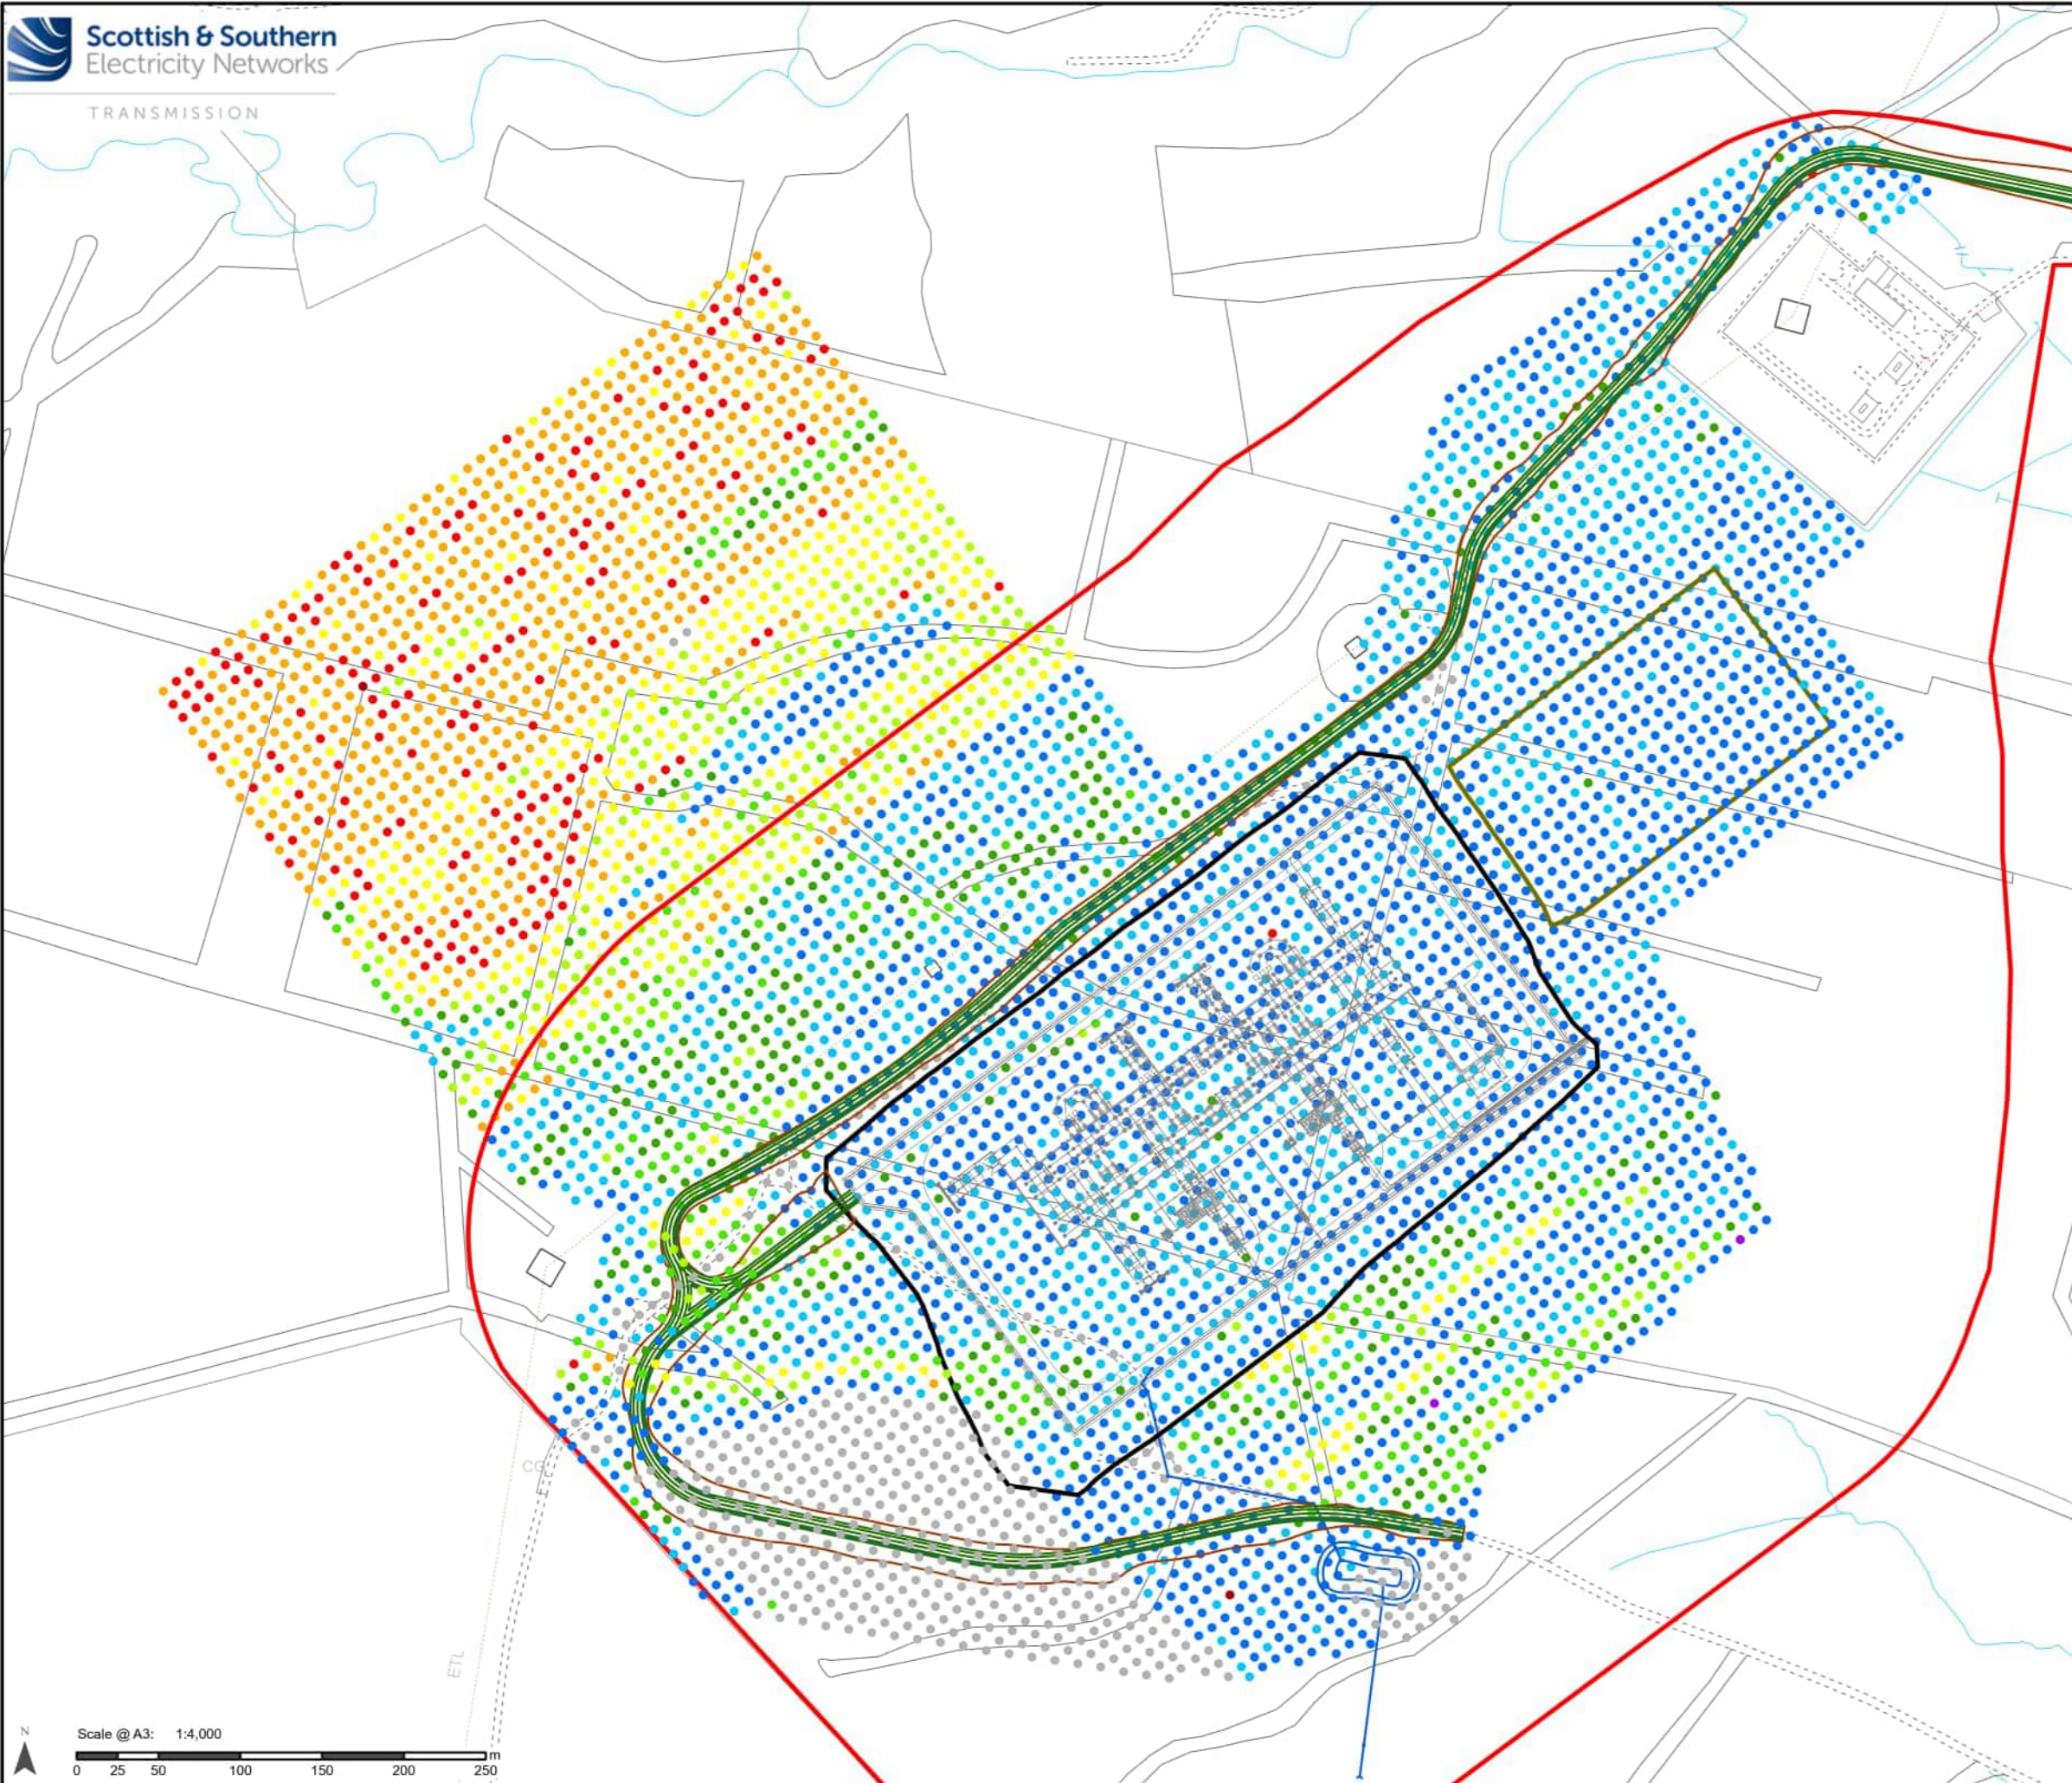
Drawing: Figure 2

Figure 2 in Appendix A shows the locations of all probing undertaken across the site (i.e. inclusive of original and additional probing), as well as providing details on the depths of peat estimated for each probe location.

Title:
Peat Probe Locations and Depths

In total 442 out of the 847 (52%) probe hole locations were completed. Within the small area to the northeast of the proposed substation peat depths ranged between 0.1m and 0.85m with an average depth of 0.35m. Within the large area to the southwest of the proposed substation peat depths ranged between 0.1m and 3.7m with an average depth of 0.96m. Typically the peat depths identified as part of the additional probing agree with the probing results from the original probing exercise with the majority of the probes recording depths <1.0m. However, deeper depths were recorded locally, all to the southwest of the proposed substation, ranging from 1.0m to 3.7m.

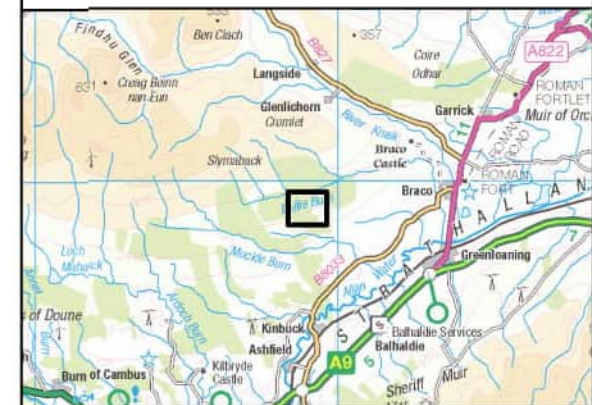
Peat Probe Depth (m)

- 0.00 - 0.50
- 0.51 - 1.00
- 1.01 - 1.50
- 1.51 - 2.00
- 2.01 - 2.50
- 2.51 - 3.00
- 3.01 - 3.50
- 3.51 - 4.00
- 4.01 - 5.00
- 5.01 +
- Unable to Survey
